MONTGOMERY COUNTY FIRE & RESCUE SERVICE
SWIFT WATER RESCUE TEAM
INTERNAL SAFETY REVIEW

Loss of JB730B at Yellow Falls on the Potomac River
Training Operations
December 14, 2016

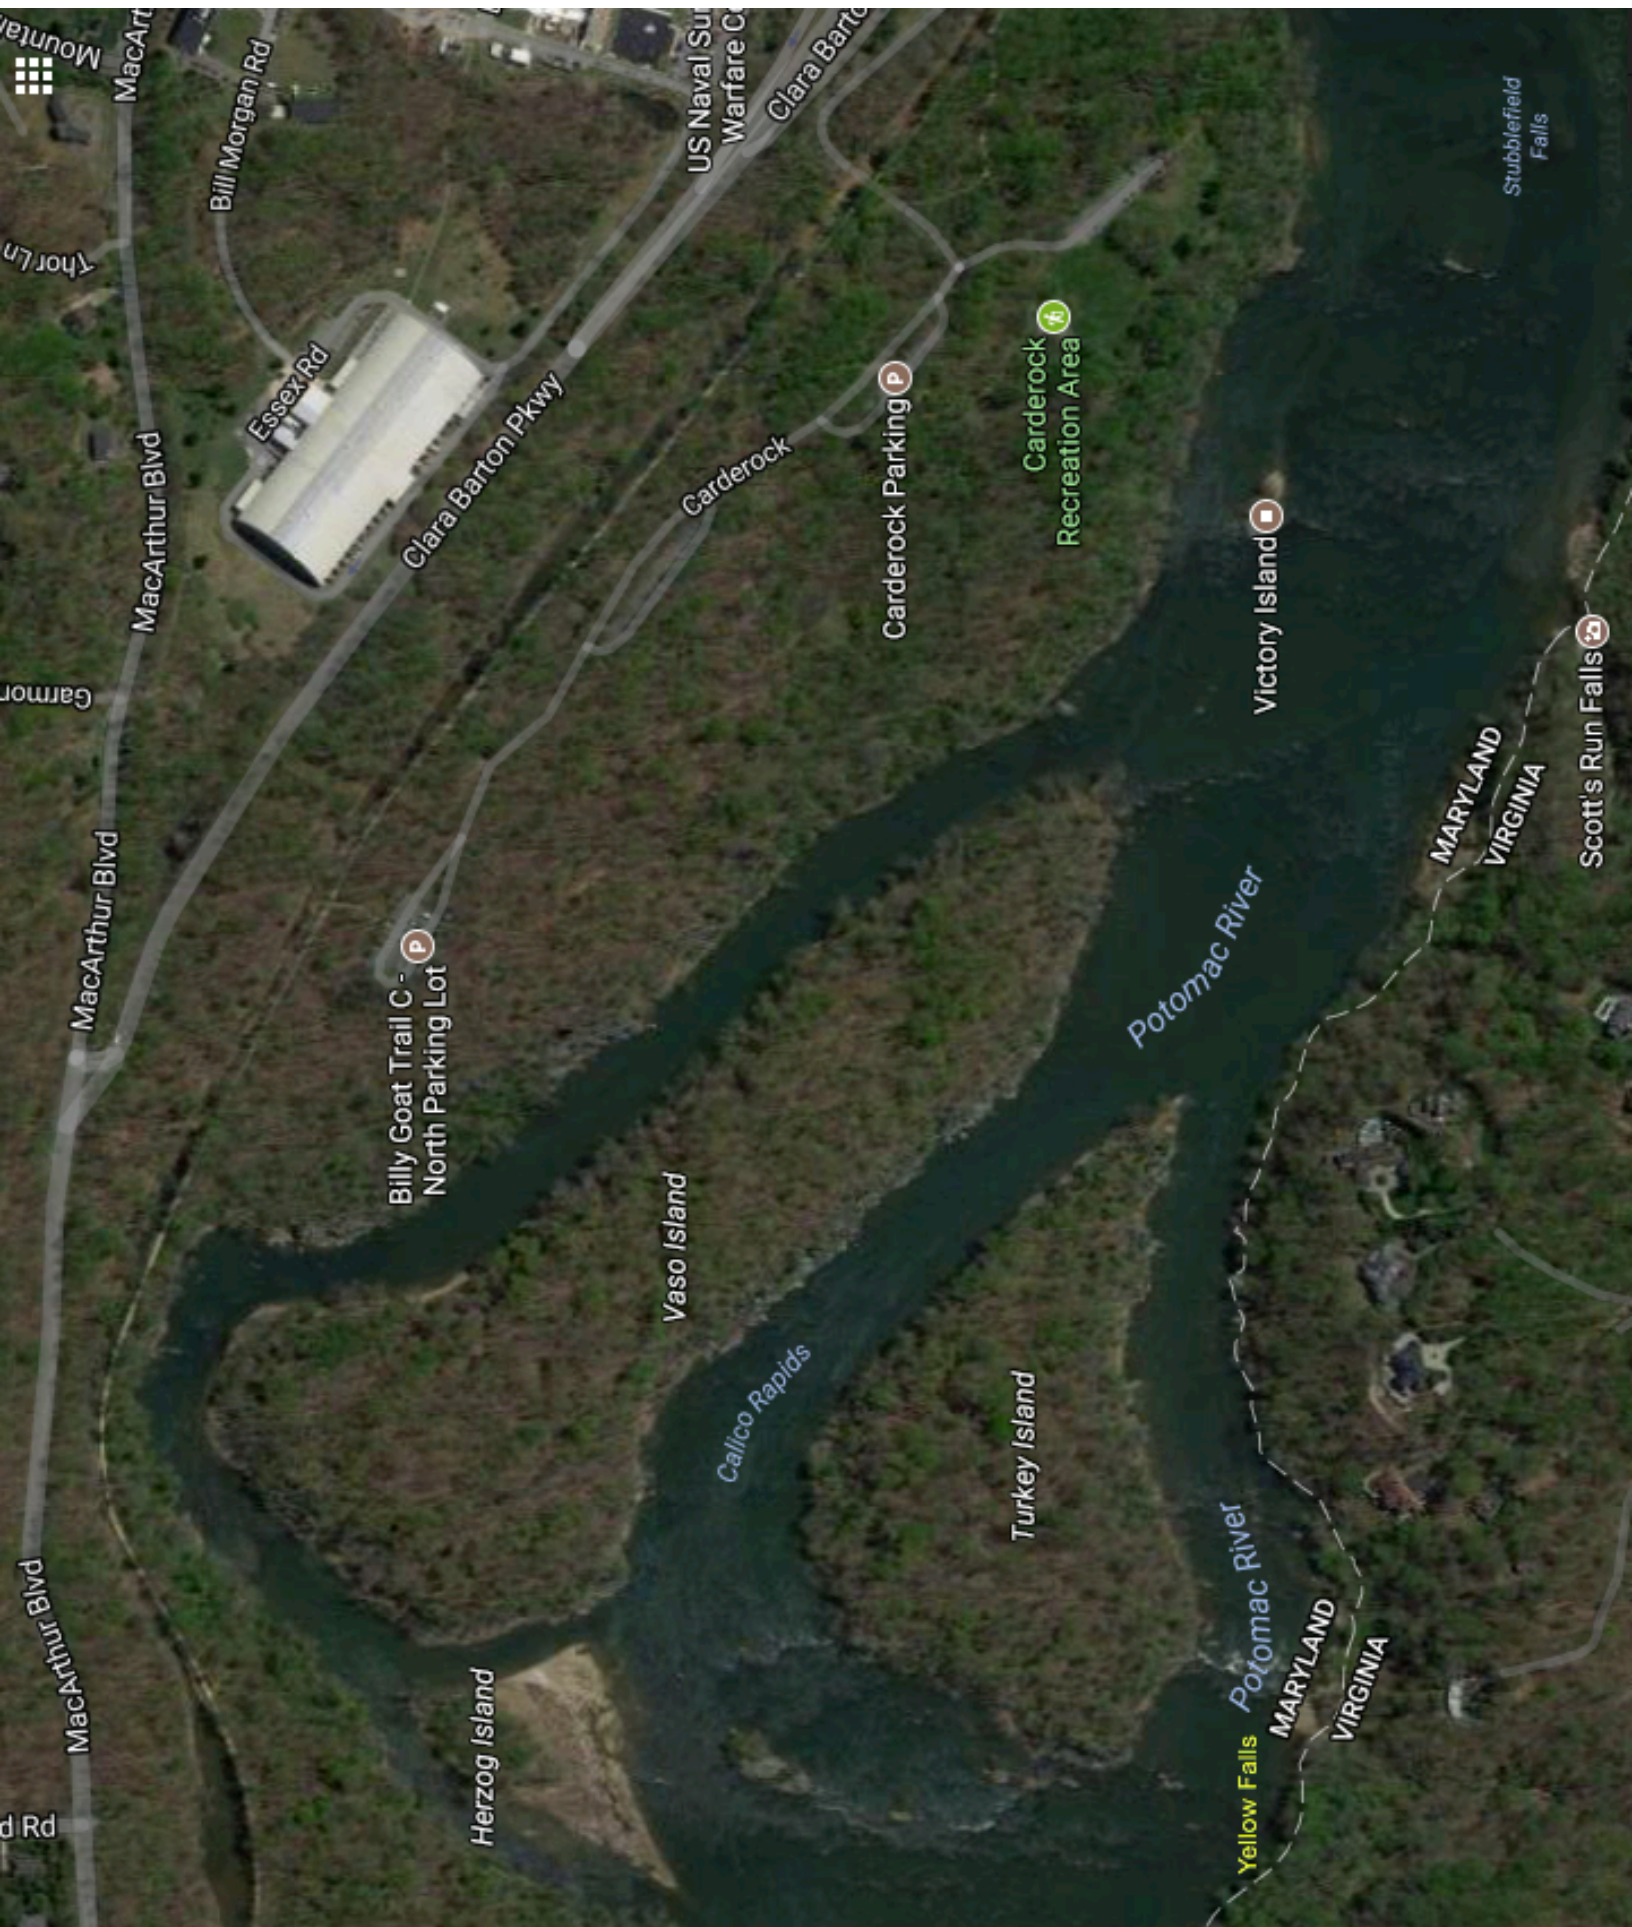
Map A

Yellow Falls is a set of rapids that sits just below the northwest corner of Turkey Island.⁴ At approximately 1300, JB730B made two attempts to get up Yellow Falls with Swift Water Boat Operator Trainee (SWBOt) “C” at the helm and SWBO “F” in the crew position. SWBOt “E” attempted and was successful in running BT730B up Yellow Falls using the same path that JB30B had just attempted to use. BT730B with SWBOt “E” and SWBO “G” held station above the falls waiting for the other boats to make their runs. SWRT members “C” and “F” switched positions with SWBO “F” at the helm and SWBOt “C” in the crew position. SWBO “F” made an attempt to run the falls. During this attempt the bow of JB730B was pushed river right by a wave. At the same time the motor was pushed out of the water. This caused the boat to lose forward momentum. When the bow of JB730B was pushed river right it hit a rock and high sided. Water started to pour over the starboard side of the boat. With the boat having no forward momentum it was quickly flooded by the incoming water. SWRT members “C” and “F” scrambled onto a nearby rock. Both made an attempt to hang onto the boat to prevent it from being swept down stream. SWBO “F” let go first. SWBOt
